Art and Archaeology Research Papers

June 1980

10. THE MAWLAWIYYA AND THE MADRASA OF SUNQUR AS-SADI WITH THE MAUSOLEUM OF HASAN SADAQA*

Guiseppe Fanfoni and Carla M. Burri

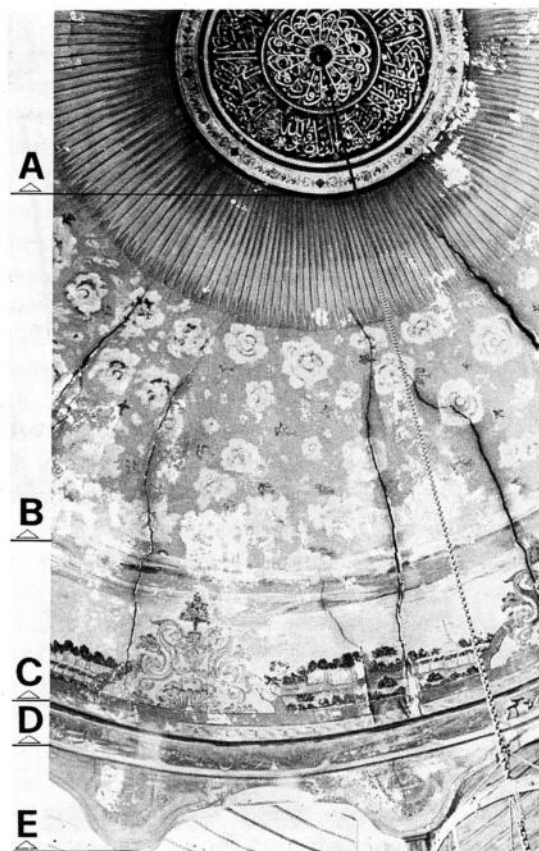
Fig. 5. Mawlawiyya: paintings in the dome.

The apex of the dome (A on Fig. 5) is filled by a circular oil painting 5 m. in diameter with calligraphy in gold on a blue ground, dating from 1857/1274. The lower part to the base of the dome shows several landscapes painted in tempera alternating with stylised floral ornaments (section C) continued as a sky with flying birds (section B).⁷ The strip of 41.5 cm. below contains an inscription frieze interrupted by squares of floral ornaments painted in oil. On the spandrels between the 12 arches of the balcony below are floral designs with central medallions (section E). Every medallion contains the name of a Dervish, except in one case (no. 12) which is possibly that of the Iranian painter: 1. Sen El Abdin, 2. Oh Hasan (invocation), 3. Oh Hasan, 4. Ali, 5. Mo'ammed Ma'di, 6. Hasan El Askari, 7. Ali Et Taki, 8. Mo'ammed Taki, 9. Ali Adler, 10. Musa Kasam, 11. Jafar Sad'ek, 12. Mo'ammed Baker.

These paintings have been thoroughly examined. Although the surface of section A is rather damaged, it is still in a state of good conservation and thus restoration here does not pose special problems. As a first measure therefore this part was chemically strengthened. The condition of sections B-C-E is worse: there the paintings are reduced to little, dry and friable particles curled and lifting from their plaster ground. Temperature and humidity variations have caused this damage, due to the holes and cracks in the outer plaster layer of the dome allowing the air to infiltrate. Structural movements have in the same way affected section D in many points, particularly where the dome drum is. Consequently the paintings of section D were oxidised and covered by dust and dirt fallen during the rain.

The precarious state of sections B-C-E required urgent measures which could not be carried out for lack of time — these had to be postponed until November (1978). Section C and the most damaged parts of sections B and E were chosen for the first operation, when the flaky surface was dampened with a 5% paraloid solution. Then the flakes were reattached to the support in a preliminary fixing. During the next stage it is planned to thoroughly clean and restore the whole surface of about 200 sq. m. A series of cleaning tests has already suggested suitable solvents for these future operations. In section D these tests revealed brightly coloured paintings. Similar cleaning and strengthening tests have been carried out with substances of several compounds, in anticipation of a thorough and systematic treatment of the masonry of sandstone.

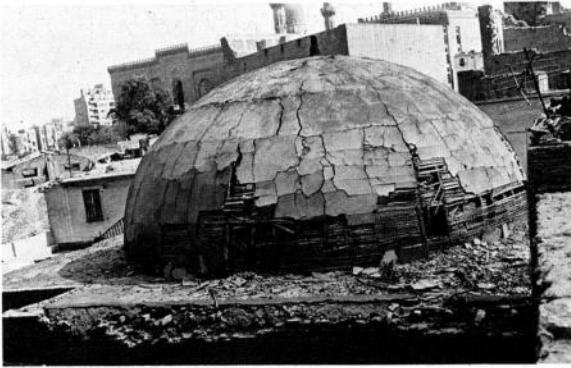
Fig. 4. Mawlawiyya: dome before restoration.

Interest in the restoration of this architectural complex stems from the importance of the theatre — the only surviving monument of this function in Cairo — and the long period during which it has been used. The most ancient parts are dated 1315/715, but they subsequently underwent repairs and alterations; a calligraphic panel still *in situ* in the theatre is even dated 1922-23/1341.⁶ Although restorations by the Comité de Conservation des Monuments de l'Art Arabe date back to the beginning of 1900, all previous work was limited to the Mausoleum. Now the poor condition of the theatre's dome, being unstable and damaged all round above the base, requires urgent restoration.

Scaffolding was built to enable the repair of the wooden structure's main points and to support the inner shell of the dome so that restoration of the painted surface of the dome could begin. The scaffolding was built in conformity with local methods, using wooden beams tied with ropes. During the erection metal clips were avoided, as the percussive vibrations set off by their use might have damaged the painted plaster. When examining the structural conditions of the first floor and the roof, it was possible to locate the main points of weakness and also to temporarily stabilise the structure to ensure stability during the stages of restoration. After this work inside the dome it was possible to start restoration on the outside, where the dome was most seriously damaged (Fig. 4): for this it was strengthened by several steel wire ropes and connecting rods 1.5 m. from the base to relieve the pressure. Then the dome's outer face was covered with

a plastic band 3 m. high, to avoid humidity penetration and to prevent the collapse of the dome.

The data gathered so far will enable a detailed plan of operation for the work of next season from November 1978 to January 1979. Then it will be necessary to remove the external shell of the dome, as its heavy load is currently endangering its precarious stability. By that time the repair of the damaged wooden parts will be possible. The roof will also be repaired and finally the protective mantle of the dome will be reset. Before this
