## **Technologies and techniques applied to the restoration in the CIERA work-site school**

The Italian-Egyptian Centre for Restoration and Archaeology (CIERA) operates as a work-site school in a monumental complex at the foot of the Citadel of Cairo, near the mosque of Sultan Hassan.

### **The Monumental area**

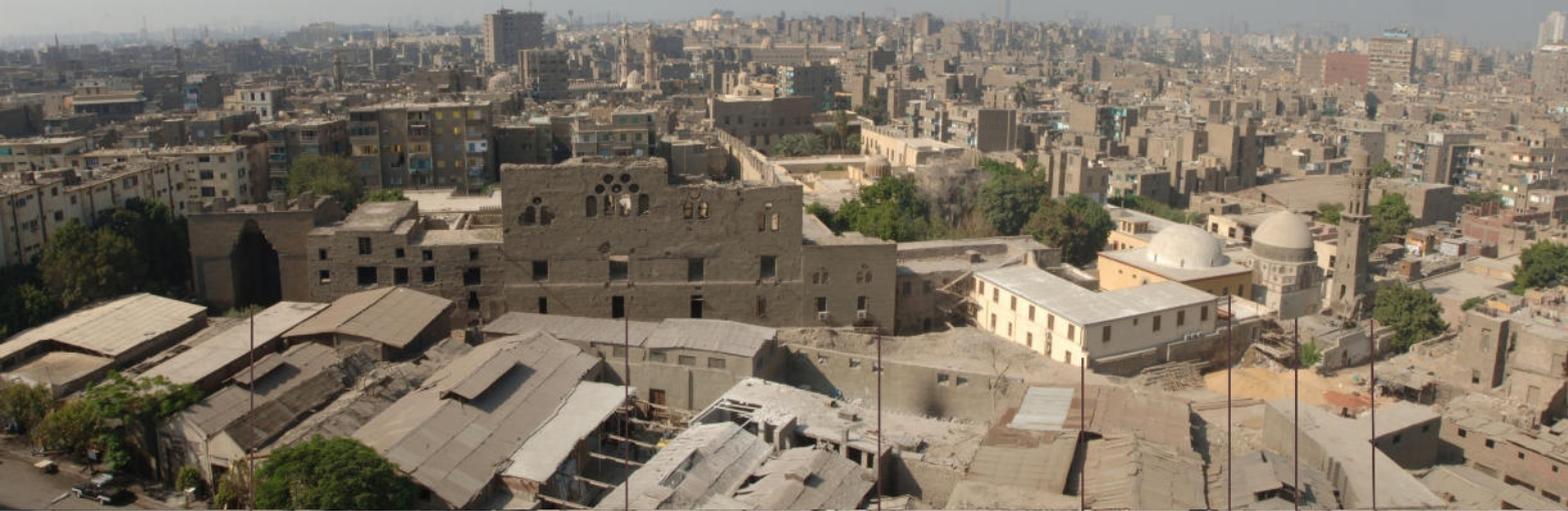
Fig. 1. GENERAL VIEW OF THE MEVLEVI ARCHITCTURAL COMPLEX

The buildings of the area are (fig.1):

- The palace of Qusun-Yashbak-Aqbardi; dating from 14<sup>th</sup> and 16<sup>th</sup> century.
- The madrasa of Sunqur Sa'di; 14<sup>th</sup> century, with the underlying archaeological area and remains of different epochs, starting from 7<sup>th</sup> century A.D., (restored by CIERA 2002).
- The mausoleum of Hasan Sadaqa, (restored by CIERA 2008), adjoining the madrasa with its minaret; 14<sup>th</sup> century.
- The takiyya, which is the Convent of the Mevlevi Dervishes (fig. 2); 16<sup>th</sup> century, (restored by CIERA 2008).
- The Sama'khana, a theatre that was built by Mevlevi Dervishes, where they performed the circular dance, typical of their mystical confraternity; starting from 18<sup>th</sup> century, (restored by CIERA 1988).

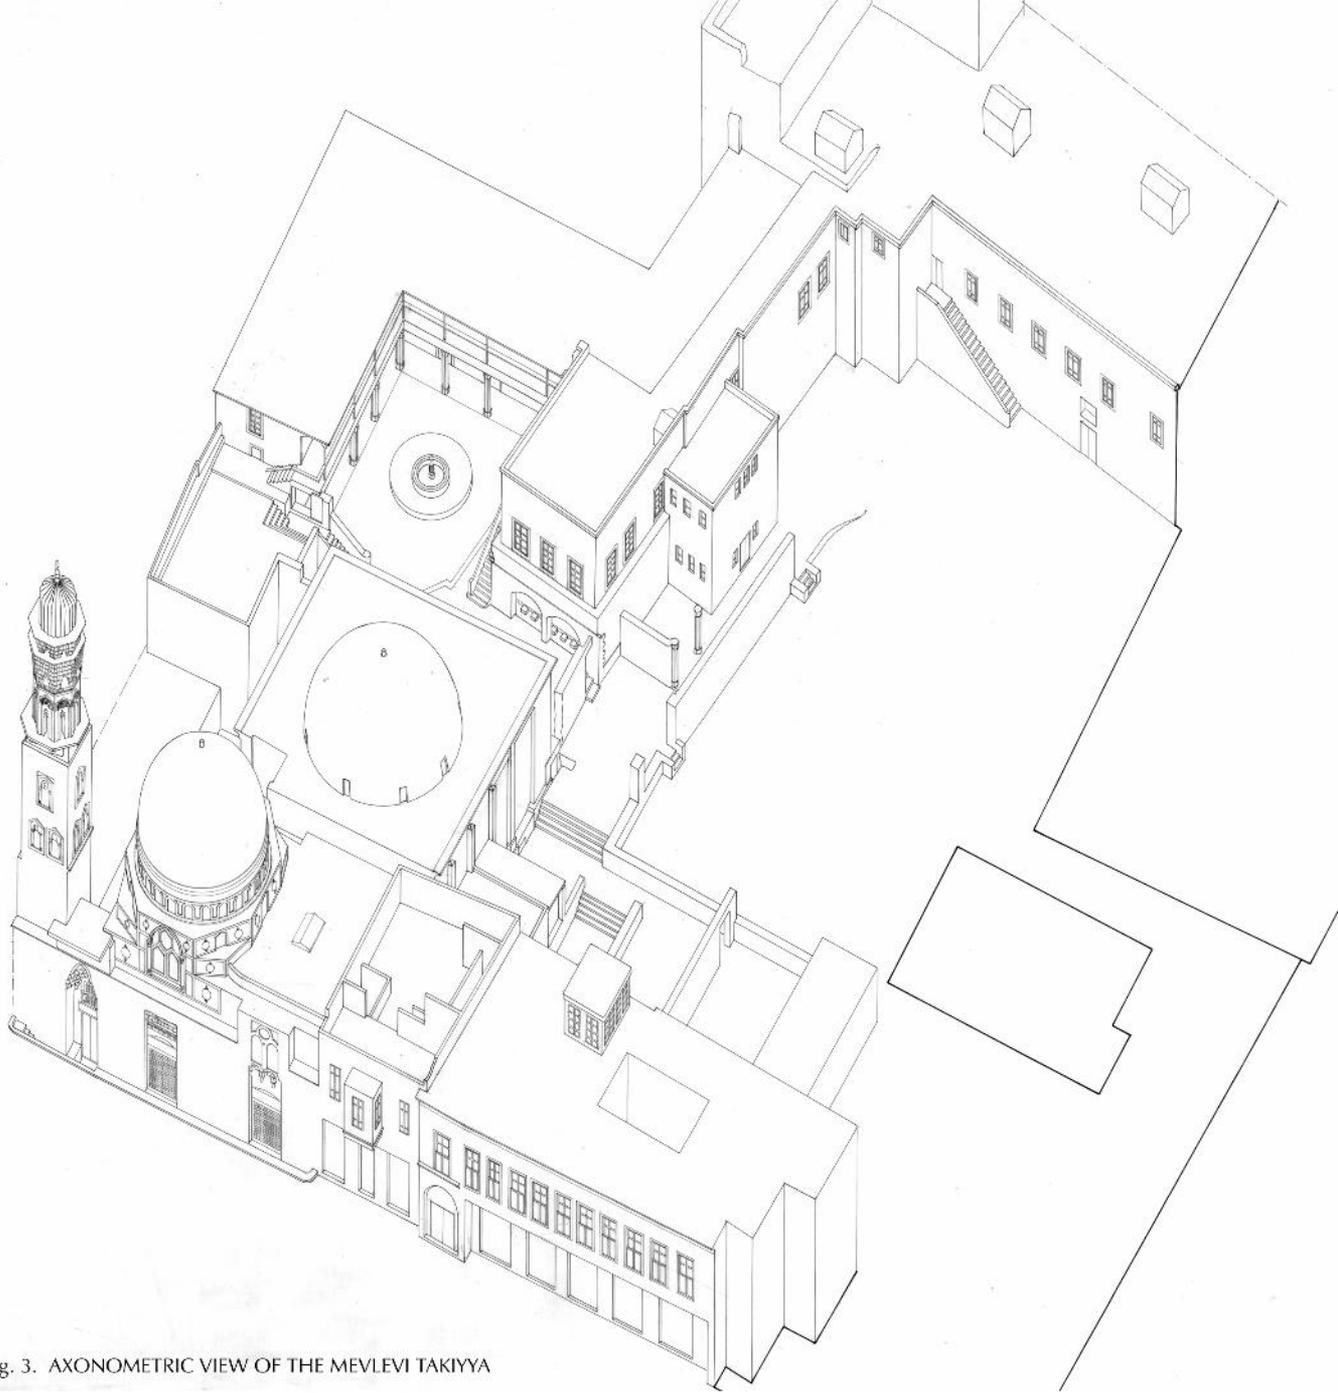
Fig. 3. AXONOMETRIC VIEW OF THE MEVLEVI TAKIYYA

The Sama'khana has a cubic shape crowned by a semi-spherical dome with a diameter of 10.50 m. The building covers an area of 250 sq m (fig. 3). The geometry and proportions of the plan as well as the vertical section reflect the elaborate symbolism connected with the Samà rite and Mevlevi

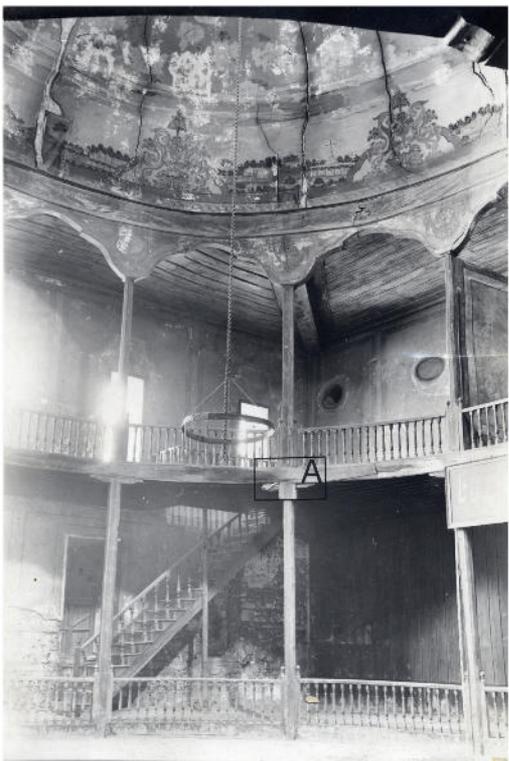
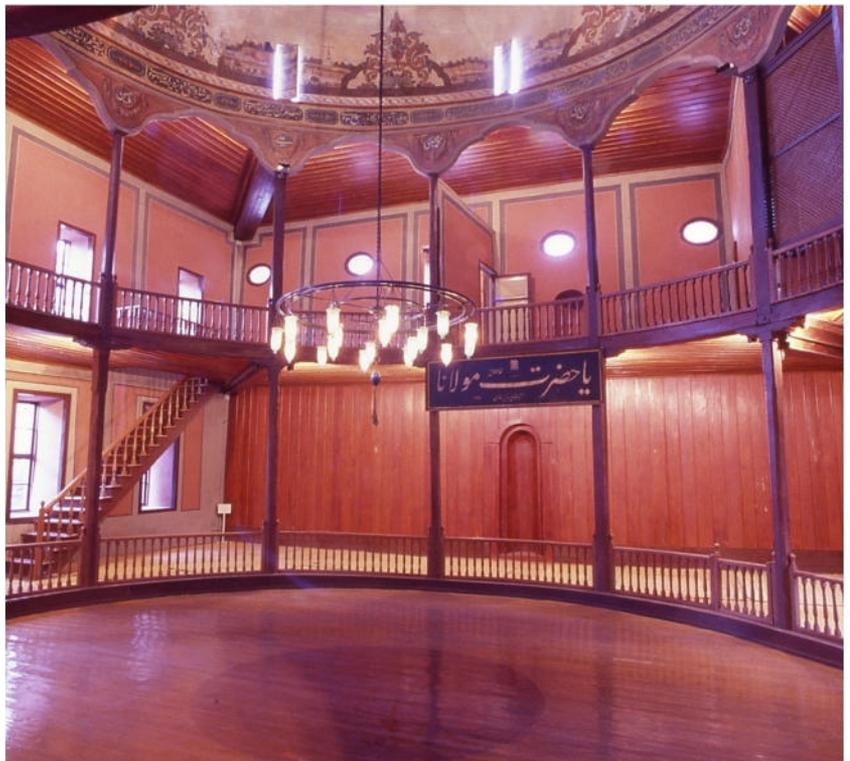
Fig. 4. INTERIOR VIEW OF THE SAMA'KHANA BEFORE AND AFTER RESTORATION

philosophy (fig. 4)

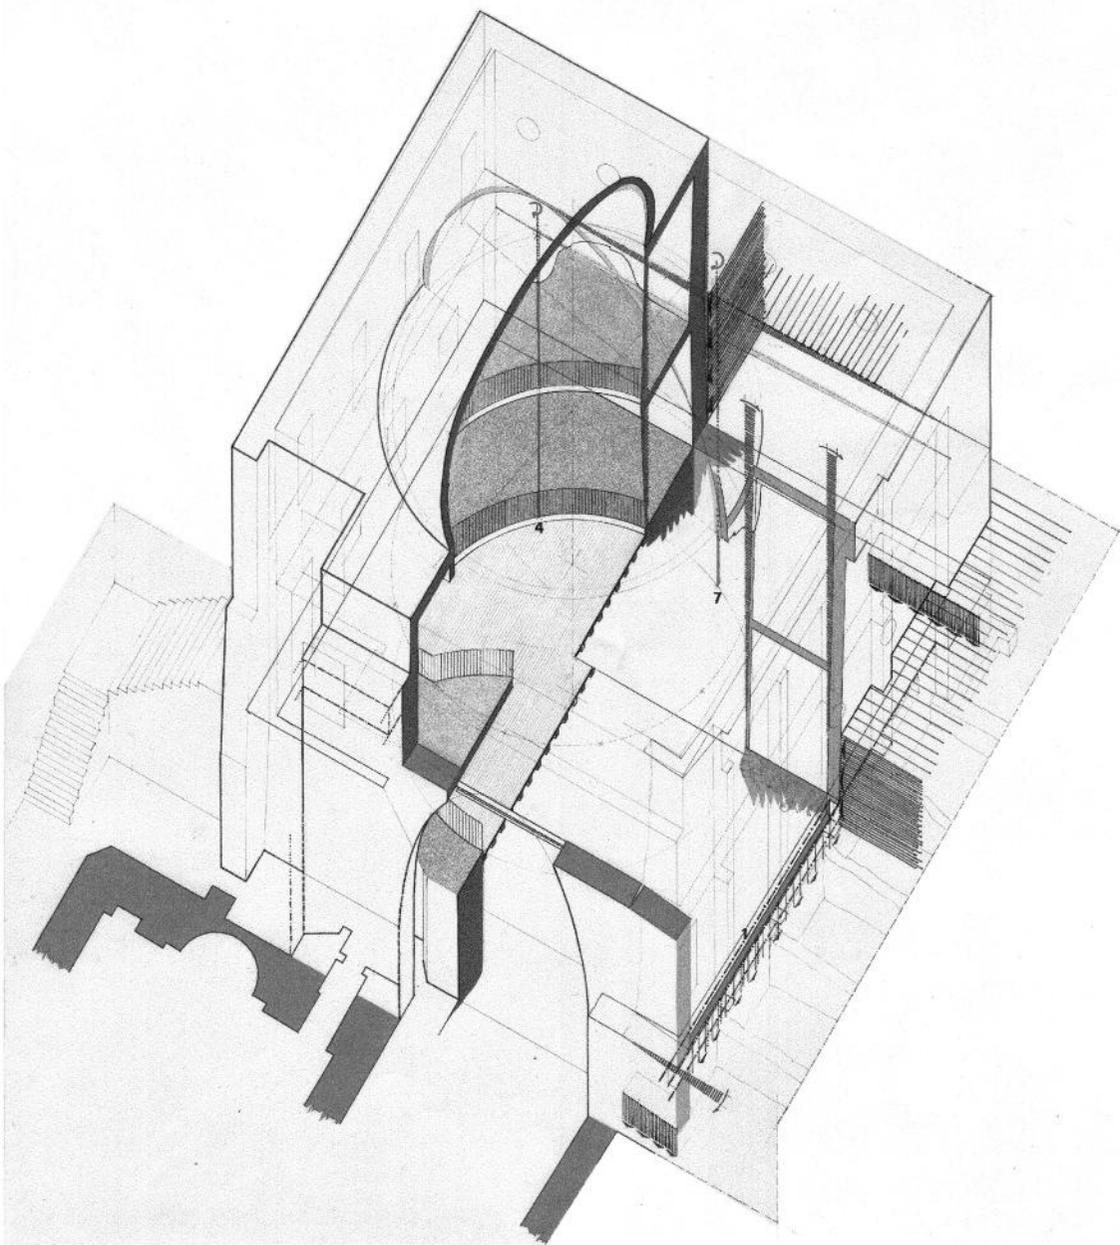
Fig. 5. SCHEME OF THE SAMA'KHANA SETTLEMENTS

The walls of the Sama'khana were suffering from various causes of decay (fig. 5). The movements of the perimetrical walls caused the interior wooden pillars to deviate out of plumb; those on the east and south were especially affected. At the gallery level, torsion of pillars in front of the mihrab on both sides pushed them outwards. The connecting corner beams were distorted due to the excessive load from the roof structure and from the opening of a stairwell at a later stage. A complex engineering operation was conducted for each of the pillars; this resulted in freeing them from the load, while necessary interventions were made on the pillars as well as the connected beams restoring them to plumb by means of system of steel members support.

| | Deformazione della cupola<br>التغير في شكل القبة<br>Deformation of the dome | | Rotazioni<br>دوران<br>Rotation |
| | Spinta della terra<br>ضغط ناتج من أتربة الأرض<br>Earth pressure | | Torsione<br>إلتواء<br>Torsion |
| | Cedimenti<br>هبوط<br>Settlement | | Posizione delle travi marcite<br>مركز الكمرات المعفنة في<br>nelle sostruzioni muro sud<br>جزء المدفون للحائط<br>Position of the rotten beams in the<br>buried south wall<br>الجنوبي |

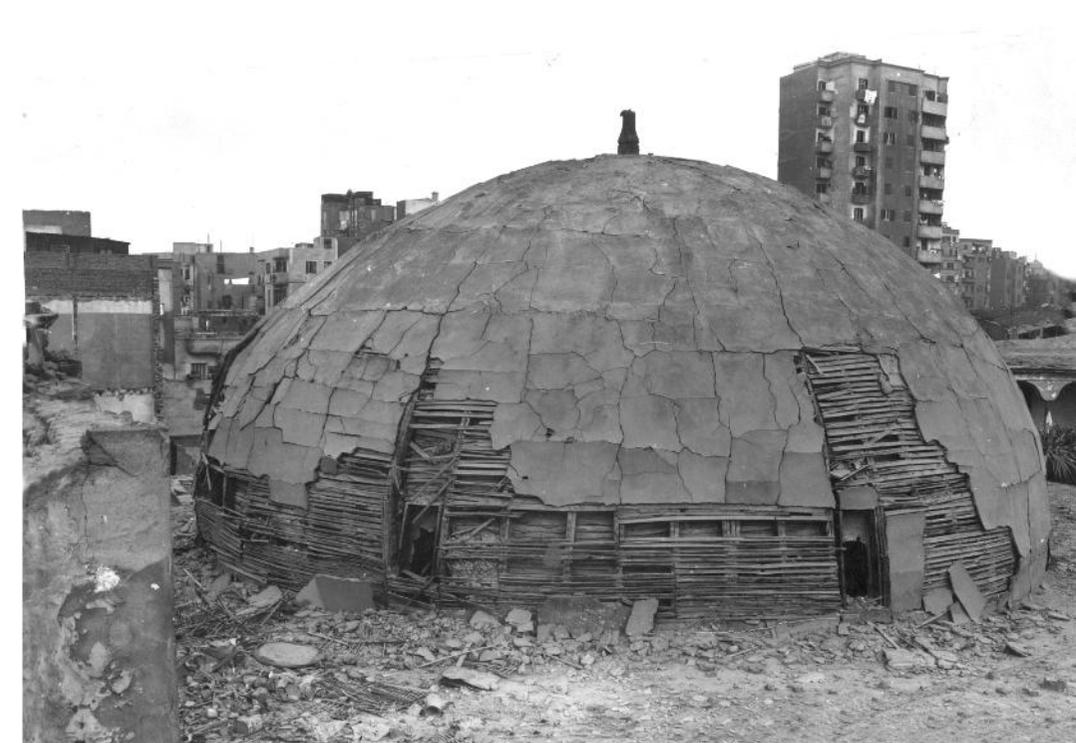
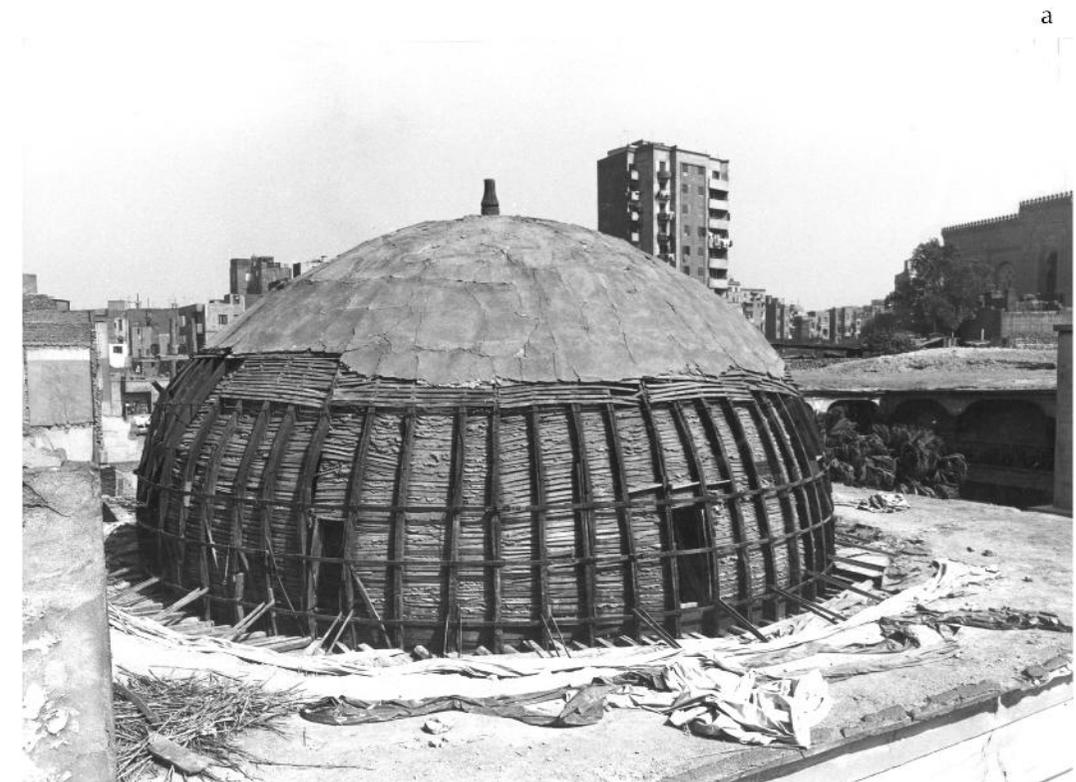
Fig. 6. THE SAMA'KHANA DOME AND THE RECOVERY OF ITS GEOMETRIC FORM

When we started the restoration work in the area, the dome of the Sama'khana was in danger of falling down as it had been flattened and distorted by a great deal of settling of the foundation (fig. 6a).

The dome, which have a circumference of 34 meters and a structural thickness of 10 cm only, is among the largest and lightest wood-constructed stuctures in Cairo.

After supporting the dome from the inside with wooden scaffolding, we applied three iron belts on the outside (composed of six elements), one of which at its reins. By tightening the bands gradually and checking the reduction of each marked crack from inside, the dome recovered its original shape as far as it was possible, (fig. 6b) reducing the perimeter, at the reins, by 20 cm, with the effect of raising the apex of the dome by 12 cm.

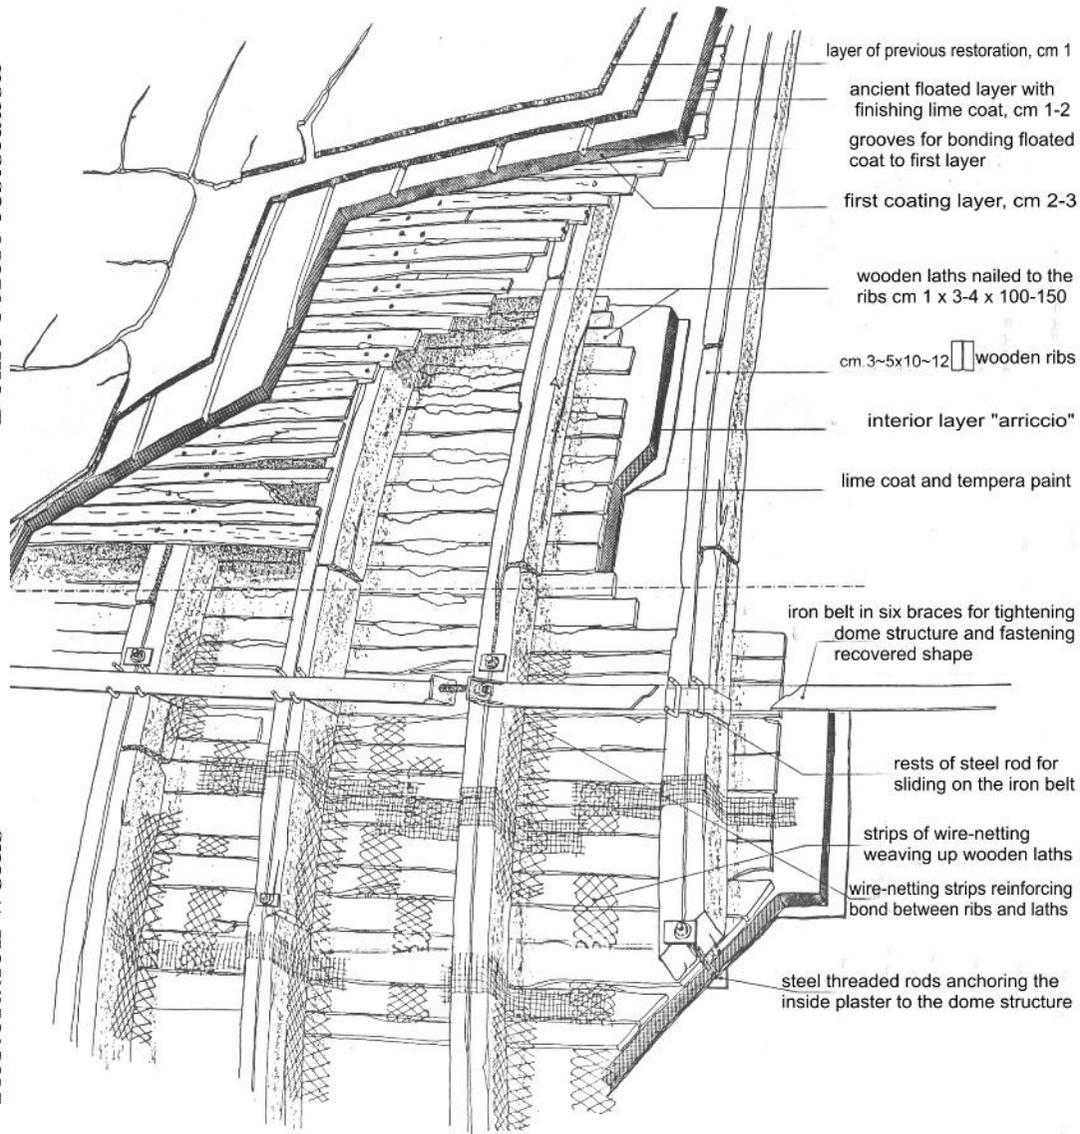
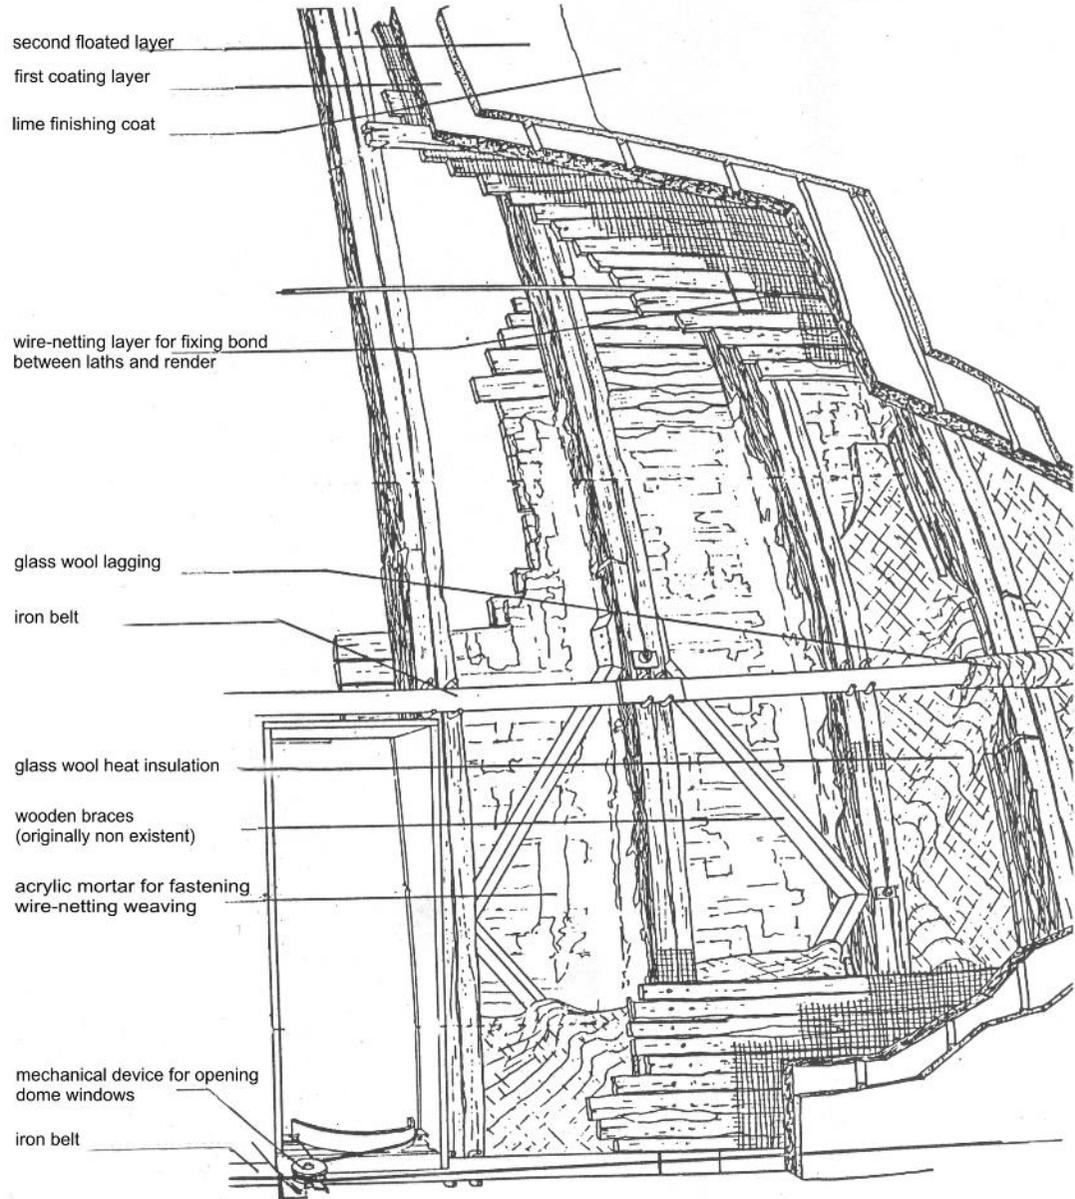
Fig. 7. STRUCTURAL ANALYSIS AND RESTORATION WORKS OF THE SAMAKHANA DOME

The laths forming a covering under and over them were sewn up with strips of wire netting (fig.7). Glass wool, as a new recognizable material, was put inside the hollow spaces for thermal insulation. Finally, for didactic purposes, a movable panel on the dome extrados allows to see the restoration work that was carried out.

The effectiveness of the intervention for the dome structure stabilization was evident in 1992, when the iron bands, mechanically sliding on the ribs, allowed to absorb any movement solicited by the earthquake, without causing disconnections to the dome.

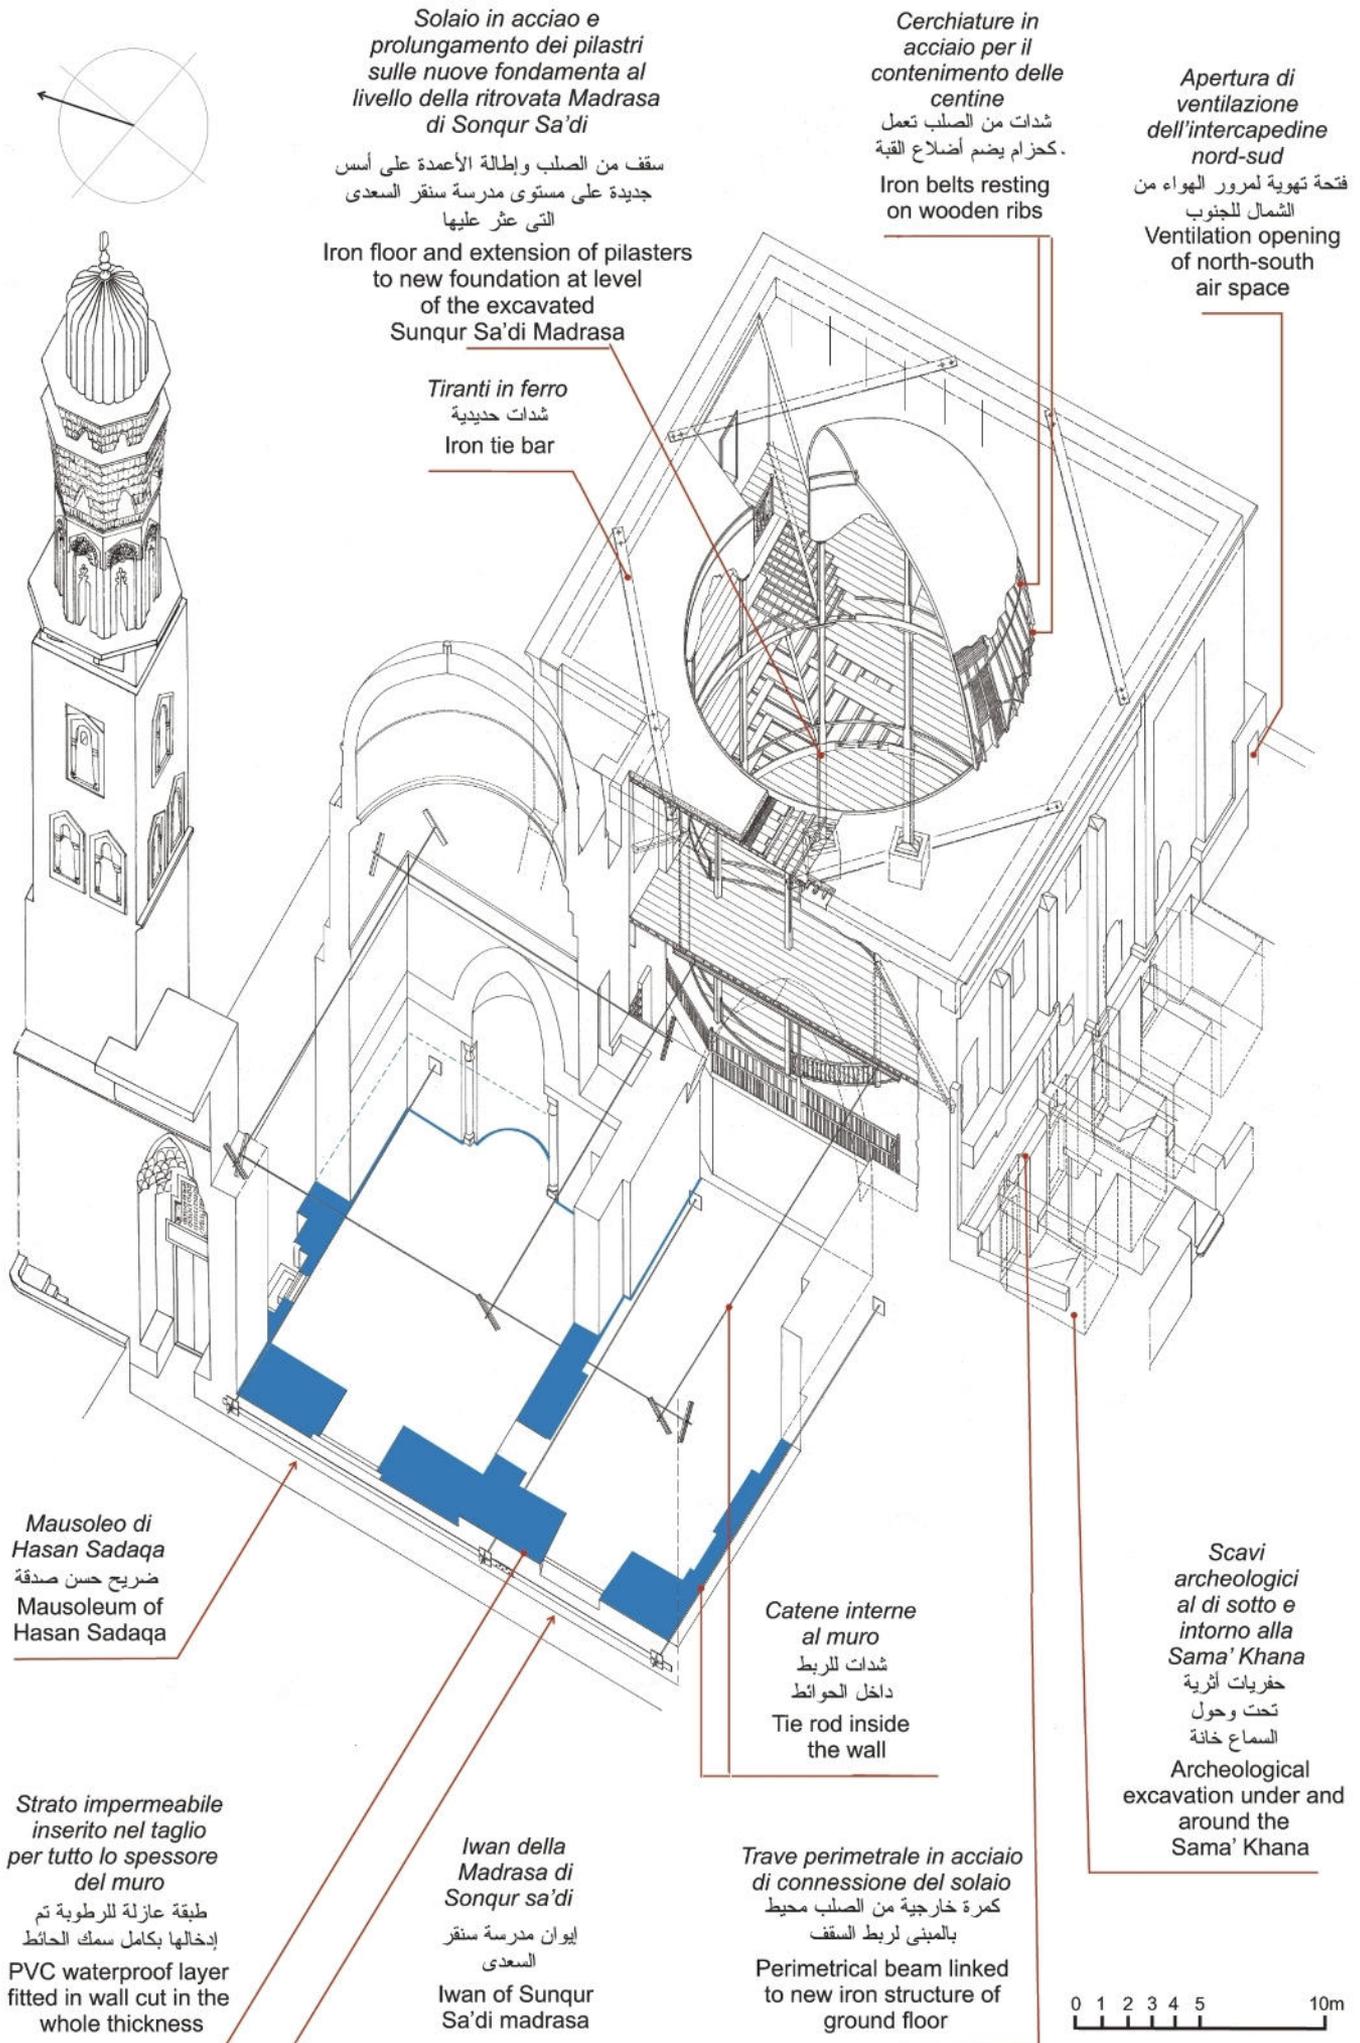
Fig. 8. AXONOMETRIC VIEW WITH DESCRIPTION OF THE RESTORATION INTERVENTIONS

All parts of the edifice were also sewn together with the support of tie-bars and iron connections system, as an anti-seismic retrofit of the building structures (fig. 8).

A perimetral concrete "cordolo" inside the thickness of the wall is fitted in deep by iron rods, linking the vertical walls with the wooden structure of the roof and the dome elements. The shape of the roof square has been strengthened by diagonal iron tie-bars anchored to the concrete "cordolo" beam.

These are the same consolidation principles which have been applied in the Sama'khana, the madrasa and mausoleum, with tie rods in site of the wall, sewing up together the various parts as an anti-seismic retrofit of the building structures (fig. 8).

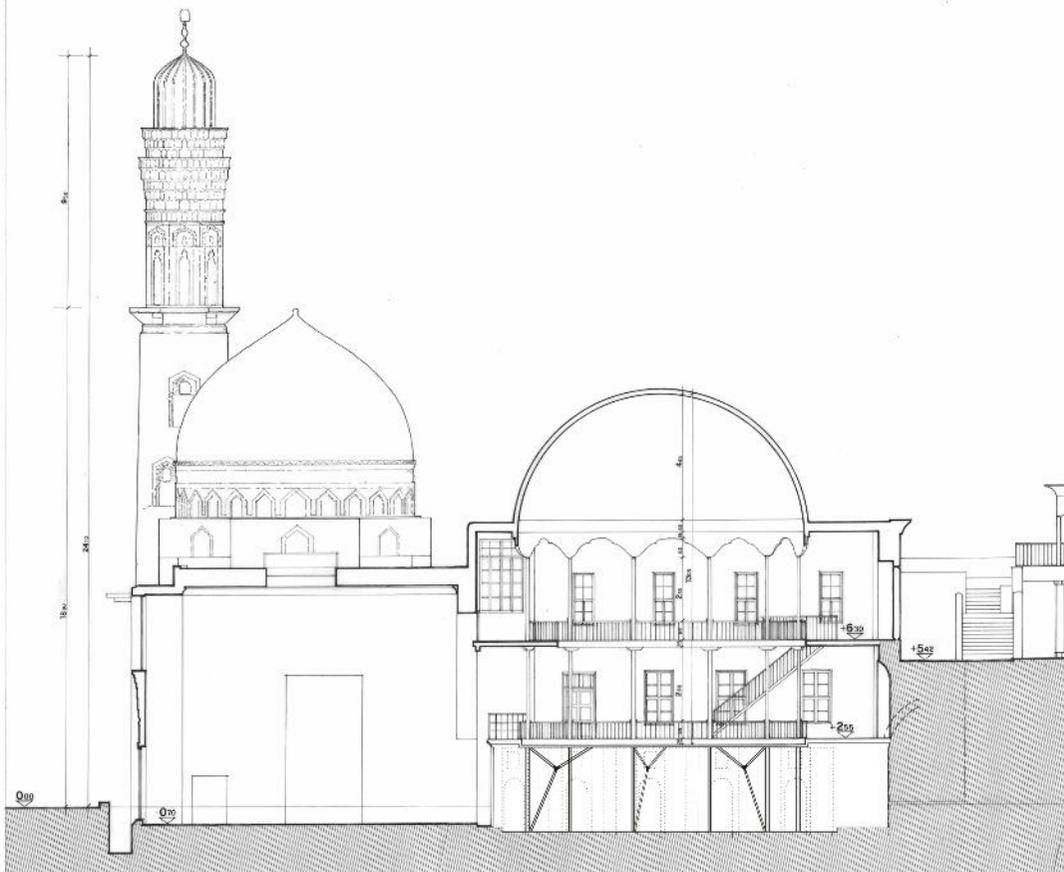
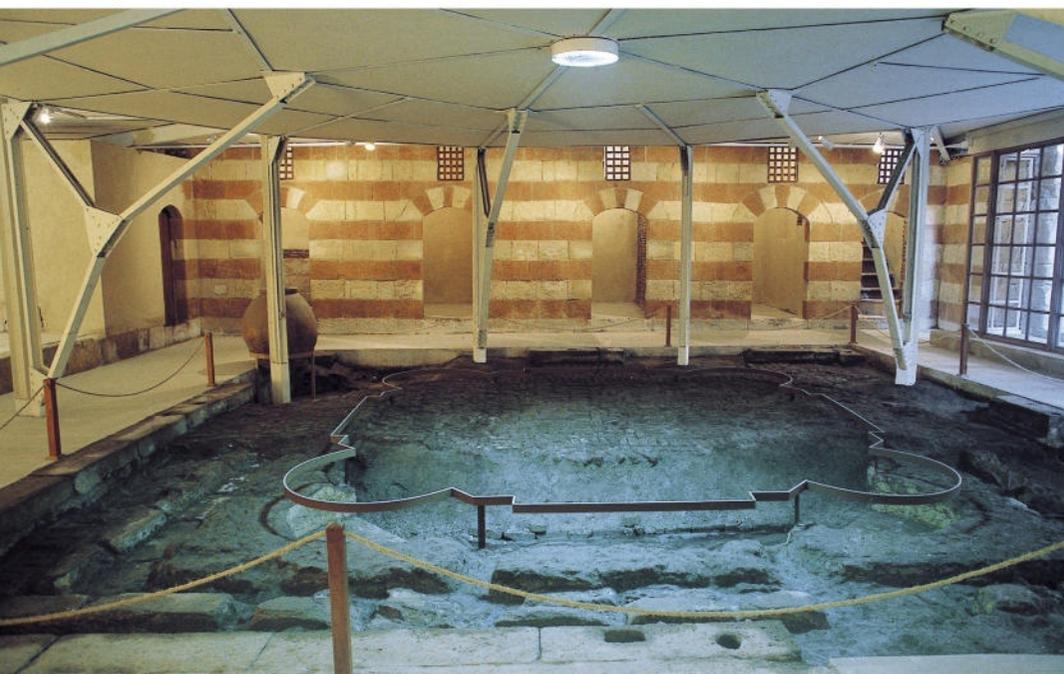
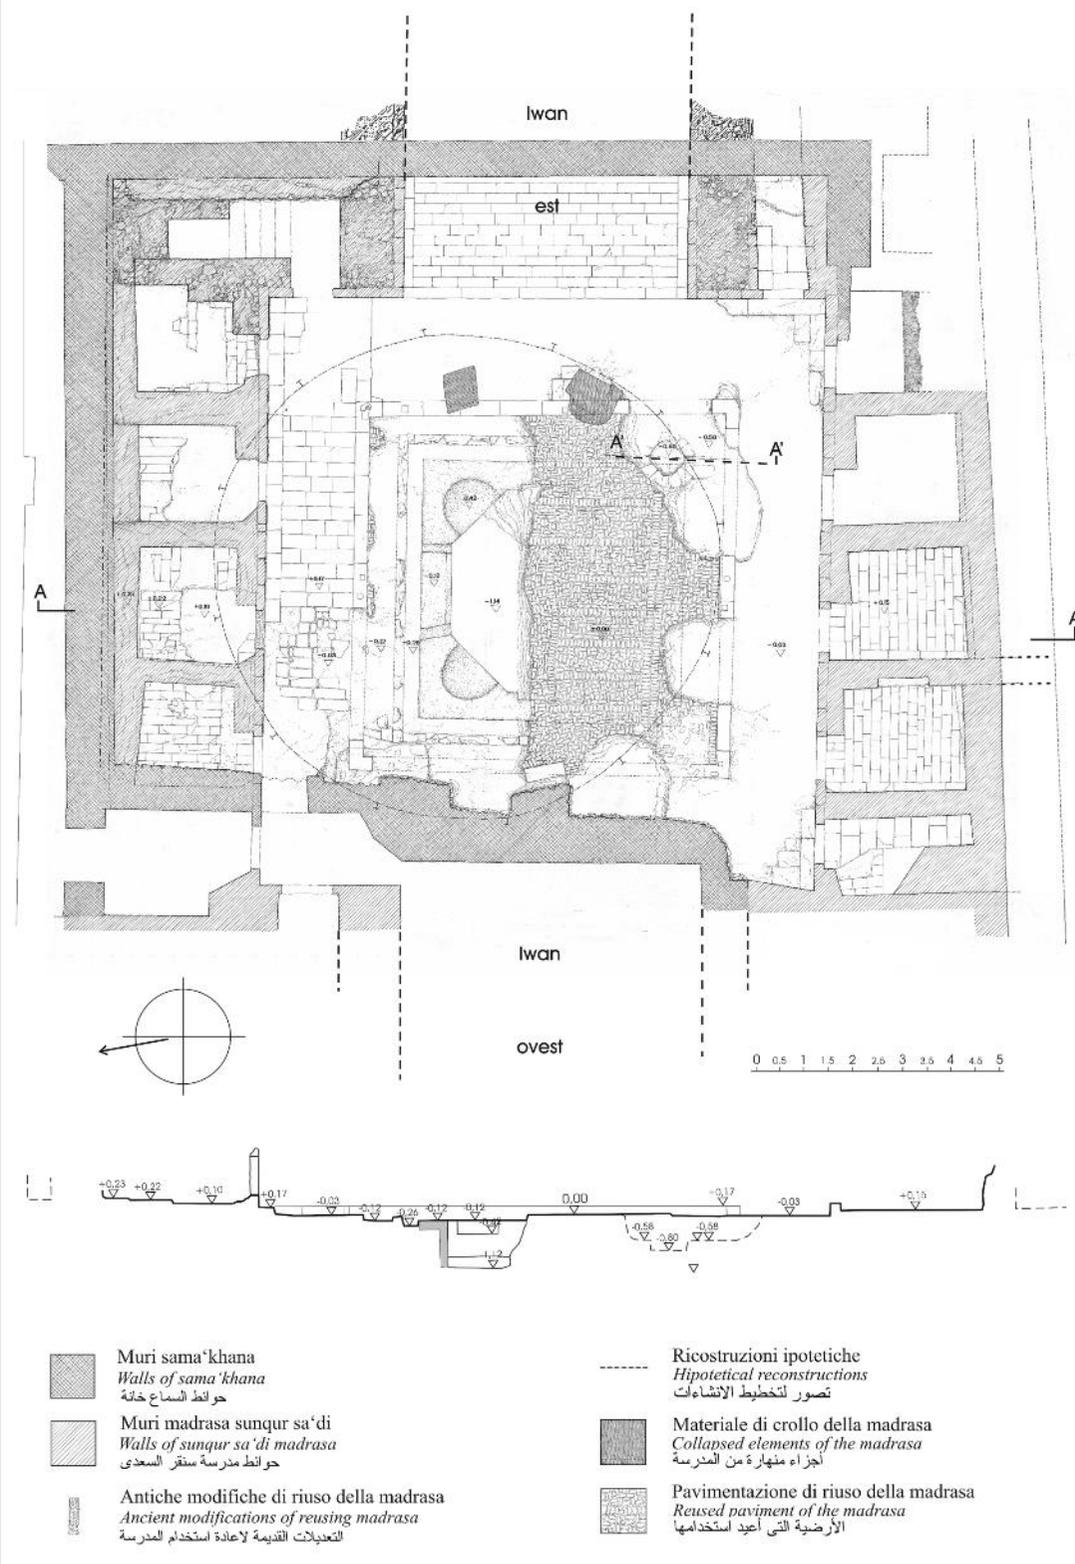
Fig. 9. SECTION OF THE SAMA'KHANA WITH THE ARCHAEOLOGICAL FINDS OF THE MADRASA

Besides, excavations conducted for the consolidation of the foundations of the Sama'khana revealed that it was constructed on sub-structures belonging to the madrasa of Sunqur Sa'di (fig. 9). We made the archaeological excavation under the Sama'khana in order to recover the madrasa under it. To support the floor of the Sama'khana, a construction of steel beams and columns resting on the level corresponding to the floor of the madrasa was introduced. Therefore, the new foundation and the iron floor linking the perimetrical walls was made as an anti-seismic connection at the ground floor level of the Sama'khana.

The plan of the madrasa of Sunqur Sa‘di, that was historically thought to have four iwans, was instead characterized by two iwans, one to the west and the other to the east in the qibla position, on the short sides of a central open courtyard with a central area paved with bricks; rooms were on the long sides of the courtyard (fig. 9).

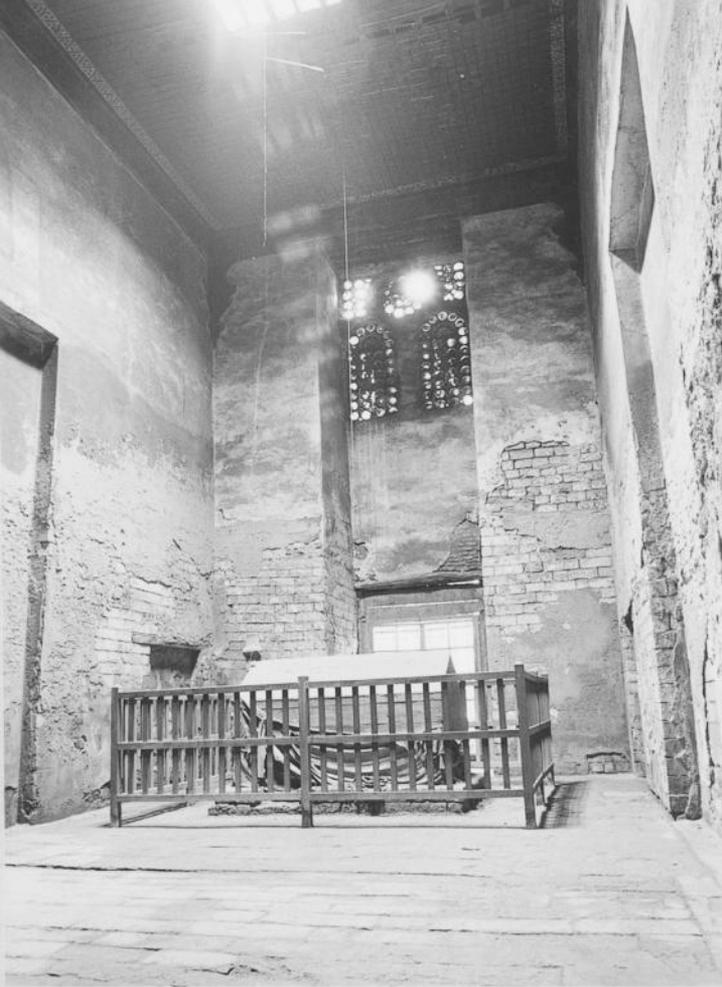
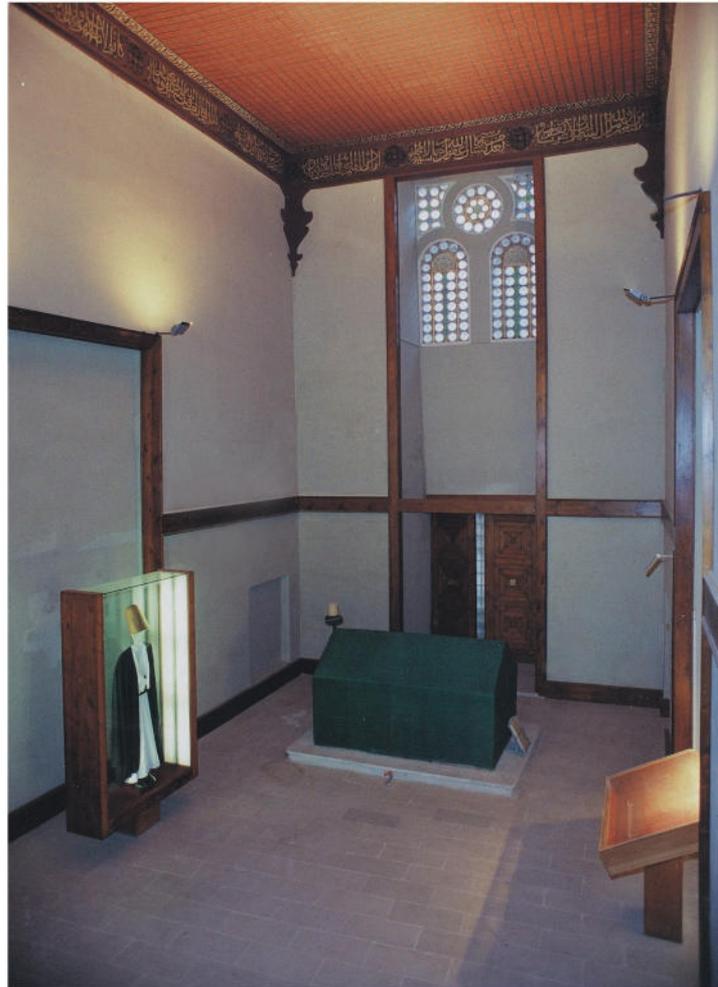
Fig. 12. THE MADRASA IWAN BEFORE AND AFTER RESTORATION

In the western iwan of the Sunqur Sa'di madrasa, (fig. 11) the integration of the missing parts of the Quranic inscription was carried out by "tratteggio", in lighter tone than the original parts, in order to differentiate them from the original ones. This way the inscription appears to be homogeneous and undifferentiated when seen from ground level (fig. 12).

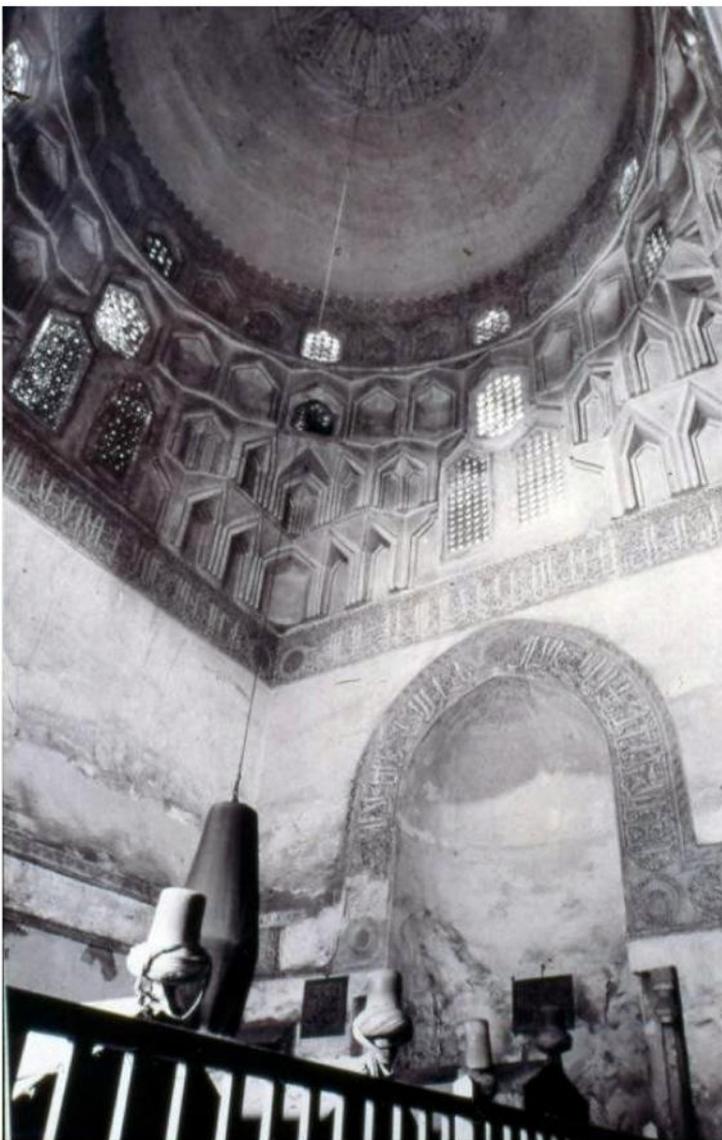
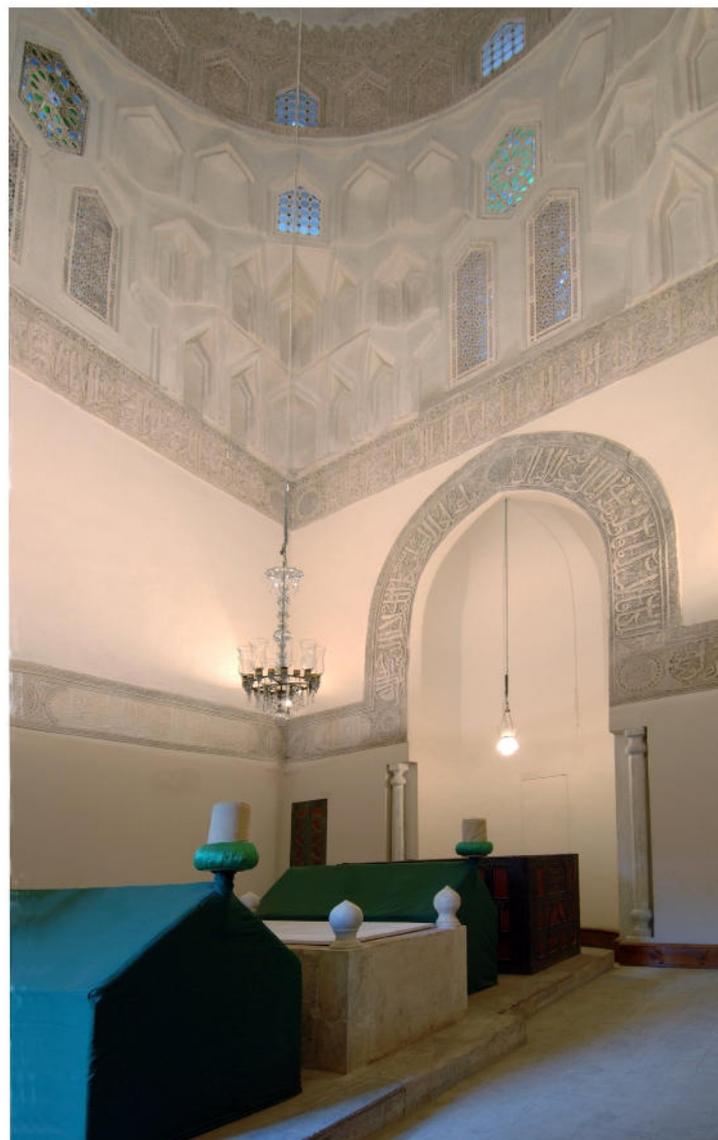
Fig. 13. SUNQUR SA'DI MAUSOLEUM BEFORE AND AFTER RESTORATION

The internal space of the mausoleum has an irregular plan (length of the sides: 8.42 x 7.93 x 8.41 x 7.73m) and reaches, at the top of the dome, a height of 18.80m. The internal space is characterized by two bands of stucco inscriptions: the first is a visual reference at the height of 3 m, and the second, at the height of approximately 7.30 m, marks the transition to the intermediate level of muqarnas, which goes up to the springer of the dome (fig. 13).

Leaking water, up to a few centimetres above the floor, has been attested in the mausoleum since the 1980, while the whole of the corridor was permanently flooded. Both inside and outside the mausoleum rising damp caused visible damage to stone facings, plaster, stucco decorations and even wall structures (fig 13).
