## **Technologies and techniques applied to the restoration in the CIERA work-site school**

The Italian-Egyptian Centre for Restoration and Archaeology (CIERA) operates as a work-site school in a monumental complex at the foot of the Citadel of Cairo, near the mosque of Sultan Hassan.

### **The Monumental area**

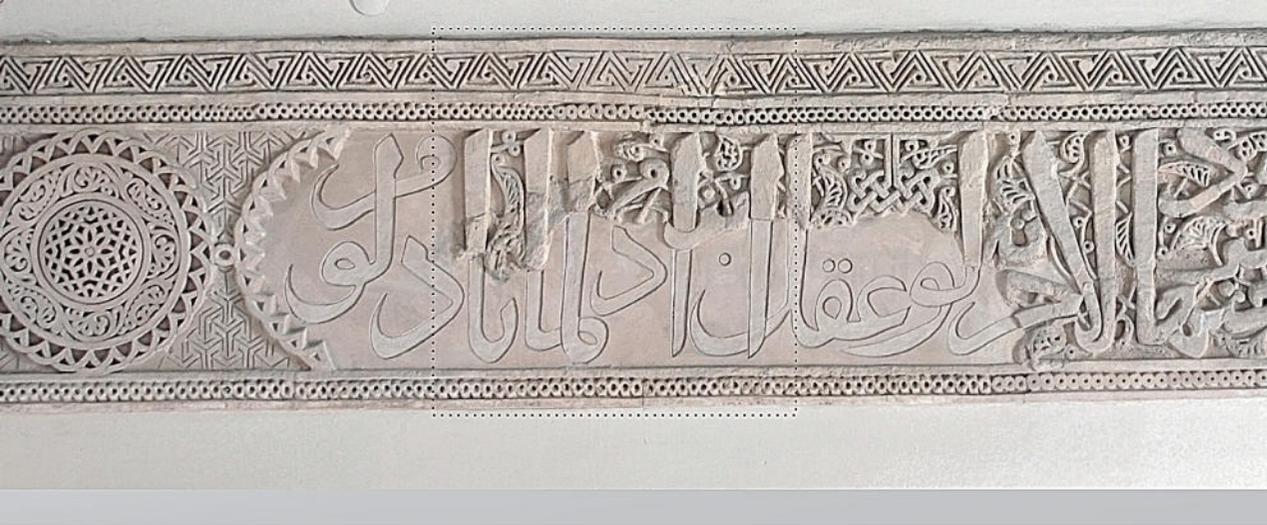
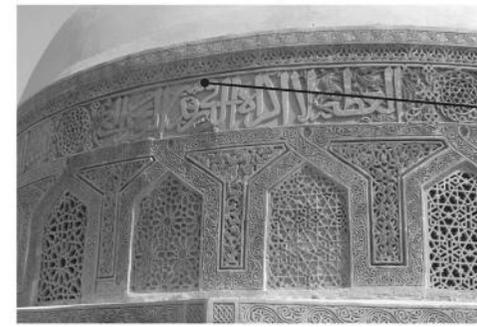
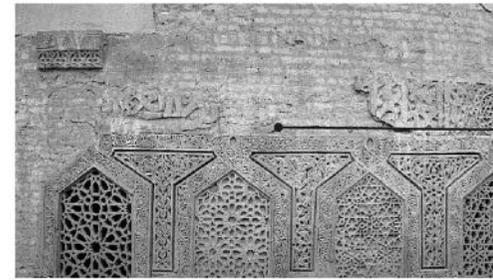
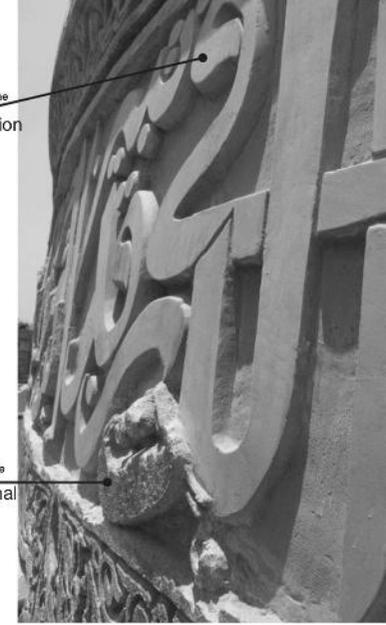
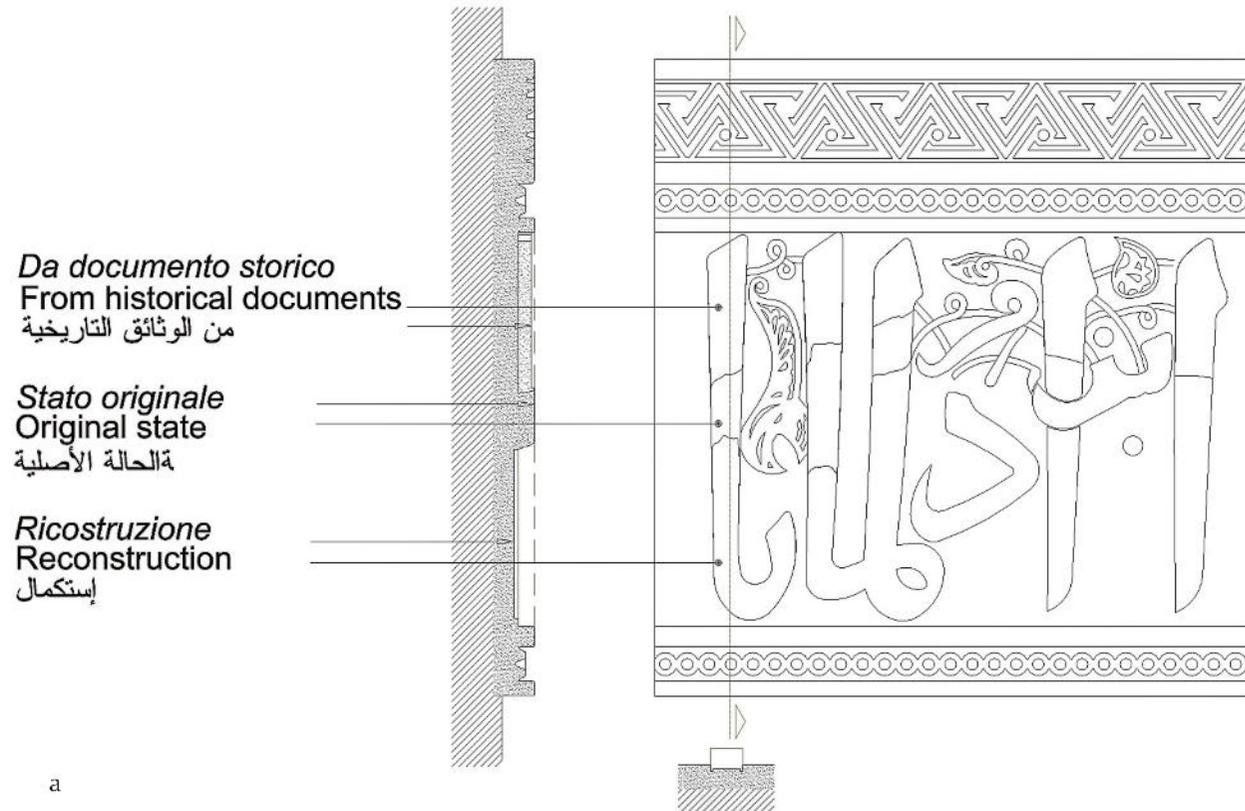
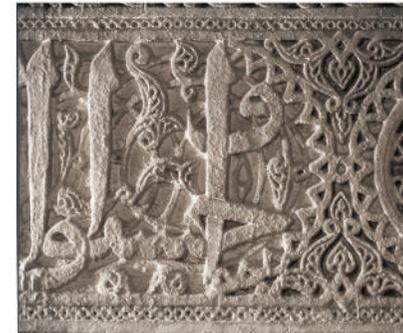
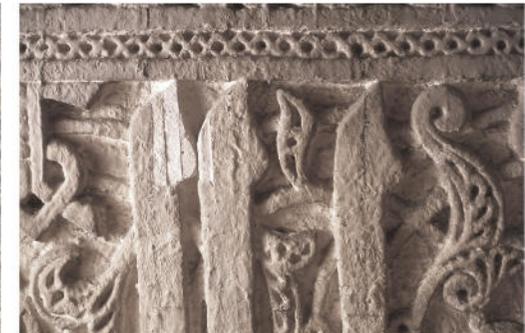
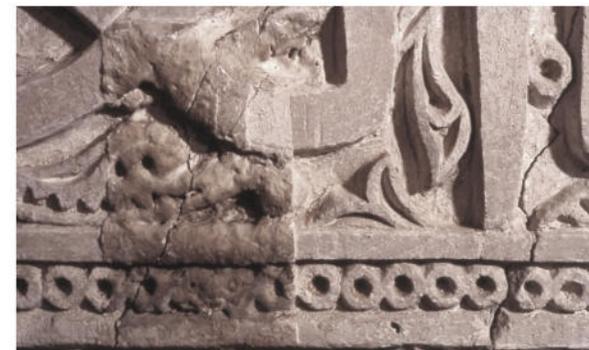
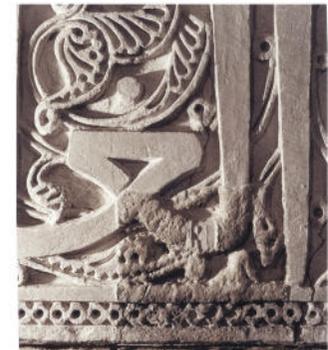
Fig. 14. VISIBILITY OF THE INSCRIPTIONS' RESTORATION ON THE INSIDE AND OUTSIDE OF THE MAUSOLEUM

In our intervention we planned different integrations to reconstruct the visual unity (fig. 14a).

Frames and repetitive decorations were completely integrated with reproductions obtained from copies of the preserved parts. Inscriptions were completed according to photographs from texts or archives, keeping the new ones 5 mm lower than the original. Those parts that were not documented were integrated according to literary reconstruction; the new letters were reproduced in negative on a level 10 mm lower than the background of the whole inscription. We highlighted the perimeter of the letters with a groove 5 mm deeper, obtaining an optical effect by which the letters come out more visible, even if in negative.

The cleaning of the upper band required long and precise manual work to remove the many different layers of "scialbatura" until the original surface was reached (fig. 14b). From a didactical point of view, this kind of practice is very useful to train both the concentration of the students and their manual skills, because when they work with chisels or similar metal tools they have to be very careful to remove the "scialbatura" without nicking the original stucco, preserving also the traces of patina previously formed on the piece.

The missing parts of the band of Quranic inscriptions at the top of the dome were reintegrated to regain the complete architectural image of the dome. For this purpose, the letters and their connections were reproduced on the basis of external and internal inscriptions, recomposing missing words. The integration differs from the original inscription in the absence of background decoration and because letters are approximately one centimeter lower than the original (fig. 14c).

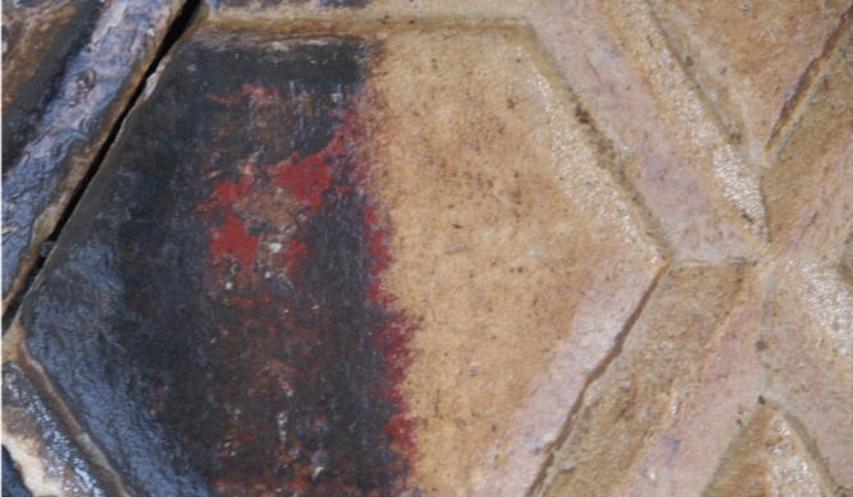
Fig. 15. TEST OF THE STONE BLACK CRUST SANDBLASTING

Cleaning the façade stone (with sandblasting machine devised by CIERA), required an attentive action in order to gradually remove the black crusts, leaving only the last patina layer, typical of the stone, not touched by sandblasting (fig 15). The controlled sandblasting action permitted to identify in some places the red layer of paint which is evident also in microscopic photographs of the thin sections on the stone (fig. 16). It might be a colouring added in 1869, when, on the occasion of the opening of the Suez Canal, all the Islamic monuments were coloured in stripes of red and yellow. This colouring had penetrated the stone, which was already altered, demonstrating that the monument did not have any colouring before that date.

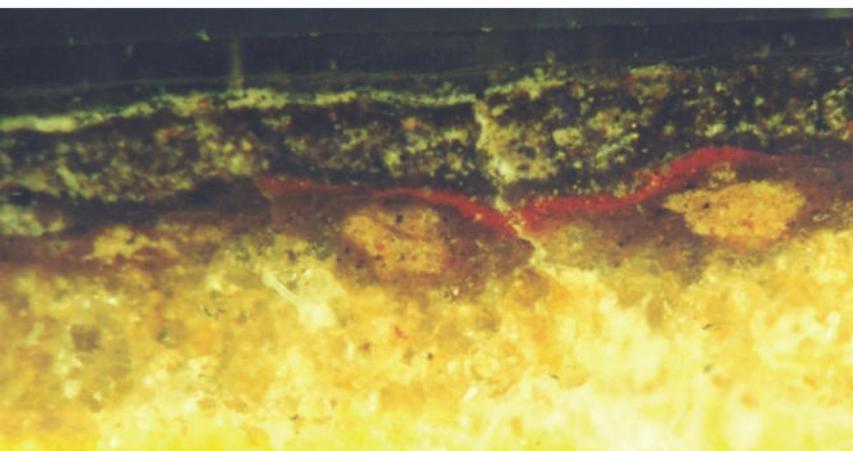
Fig. 16. MICROSCOPIC THIN SECTIONS OF THE BLACK CRUST

On the façade of the mausoleum, rising damp interacted with atmospheric pollution causing the formation of black crusts on stone facings.

The crusts formed on the intermediate sector of the façade including the area of the evaporation of rising damp. Crusts are less evident in the soaked lower part and in the upper part not affected by rising damp.

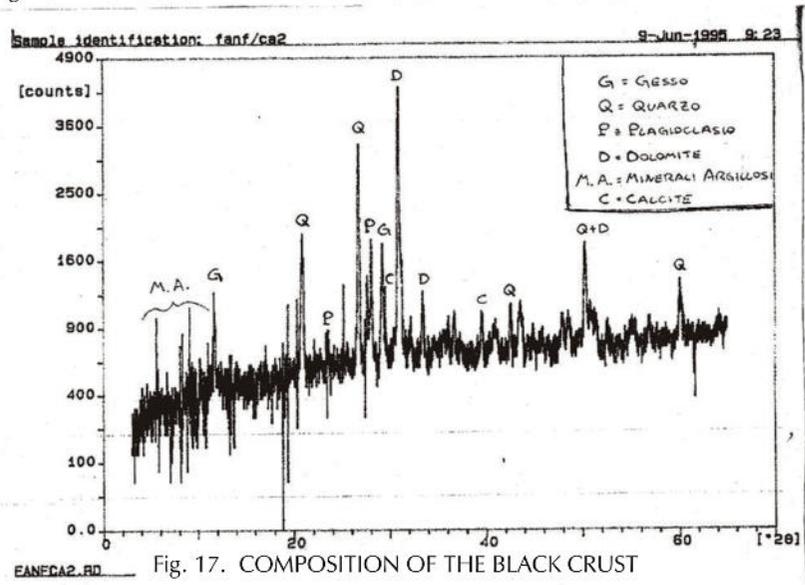
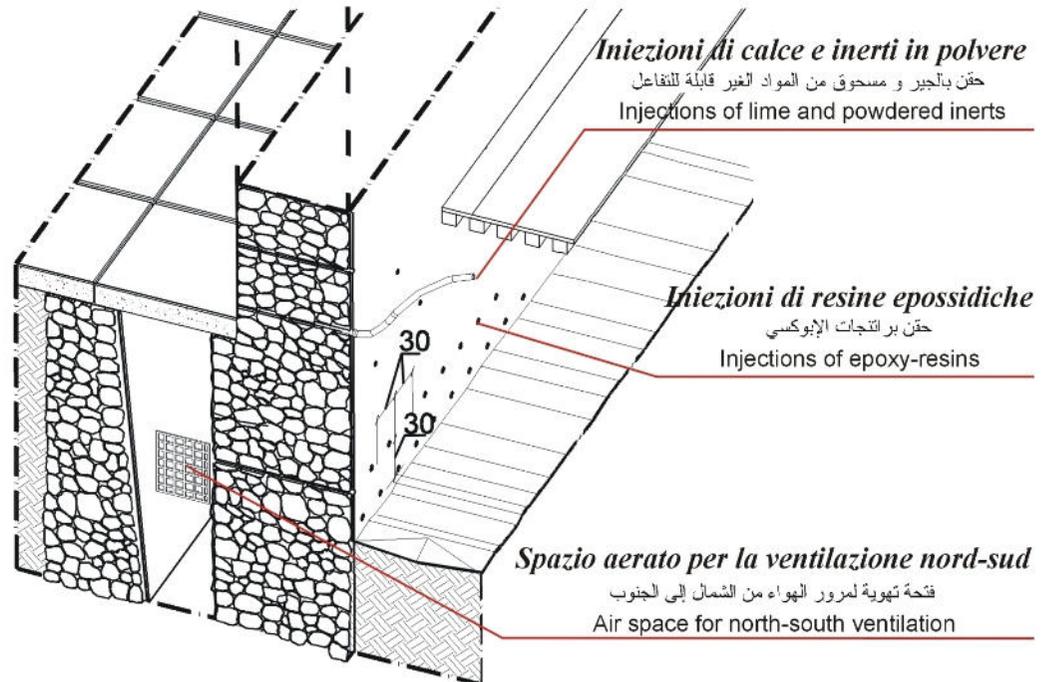
Fig. 18. ELIMINATION OF RISING DAMP FROM THE SAMAKHANA WALLS

For the elimination of humidity in the Sama'khana walls, we made two rows of holes, filled with injections of particular epoxy-resins spanning the entire thickness of walls directly under floor level, providing a damp-proof course to solve the problem within the structure (fig. 18). But the complete elimination of dampness was ultimately ensured by means of a one-meter-wide air space excavated around the Sama'khana with two openings on the north and the south in order to provide continuous ventilation, which effectively solved the problem (figg. 8, 18).

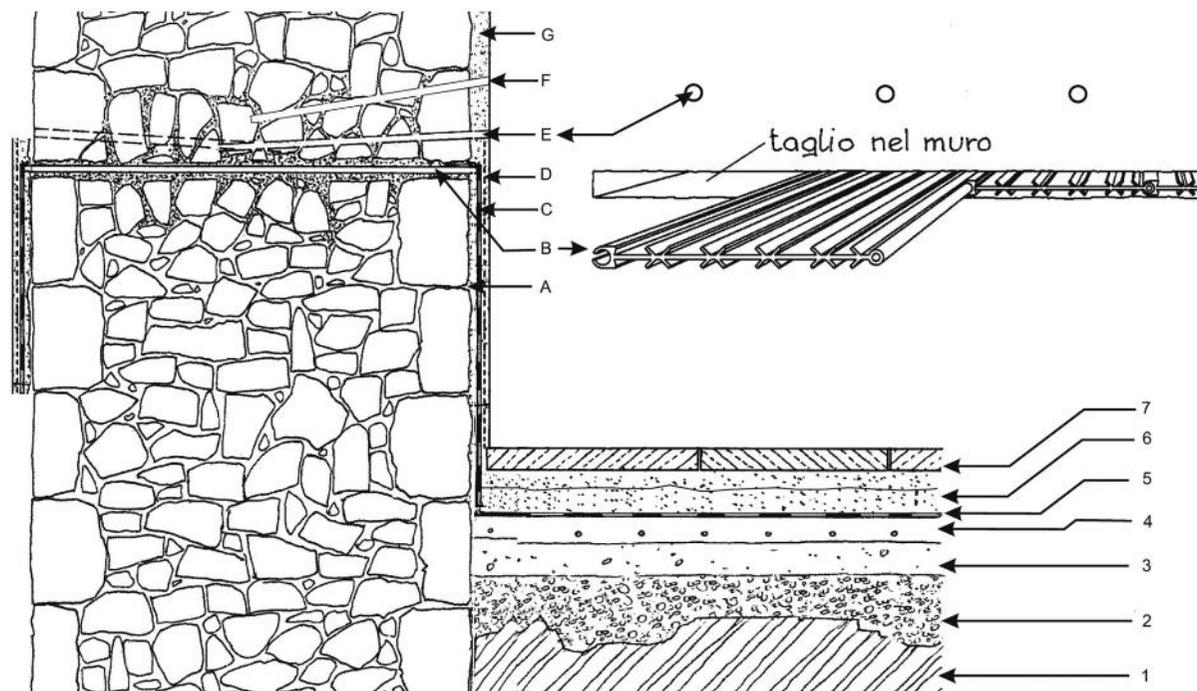
Fig. 19. THE PHYSICAL BARRIER OF MOISTURE IN THE MADRASA AND THE MAUSOLEUM

In this case, we have resorted to modern technologies as in the new buildings, where an insulated bitumen layer is used for setting a physical block against the water present in the foundations. But, since the new technique was applied to an old building, it consisted of cutting the walls at the base and inserting in it a waterproof layer throughout the entire thickness of the wall (fig. 19).

We are using special machinery for cutting the walls, made in Italy and sponsored by the Italian firm Ansaldo. It works with a three meters long blade, made by CIERA in Egypt with a special steel alloy, and lodging the sprocket-chain operating the cutting.

After cutting 20-50 cm or more of the wall in the whole thickness, strips of PVC of special shape (from Italian Umiblok) were inserted in the void, with the injection of the particular mixture of expansion-controlled and sulphate-proof ferric cement without chlorides, sponsored by Italian Pagel.

This seam operation has also the characteristics of an anti-seismic structure, since it forms a joining “cordolo” of the all perimetrical walls at the foundation base.

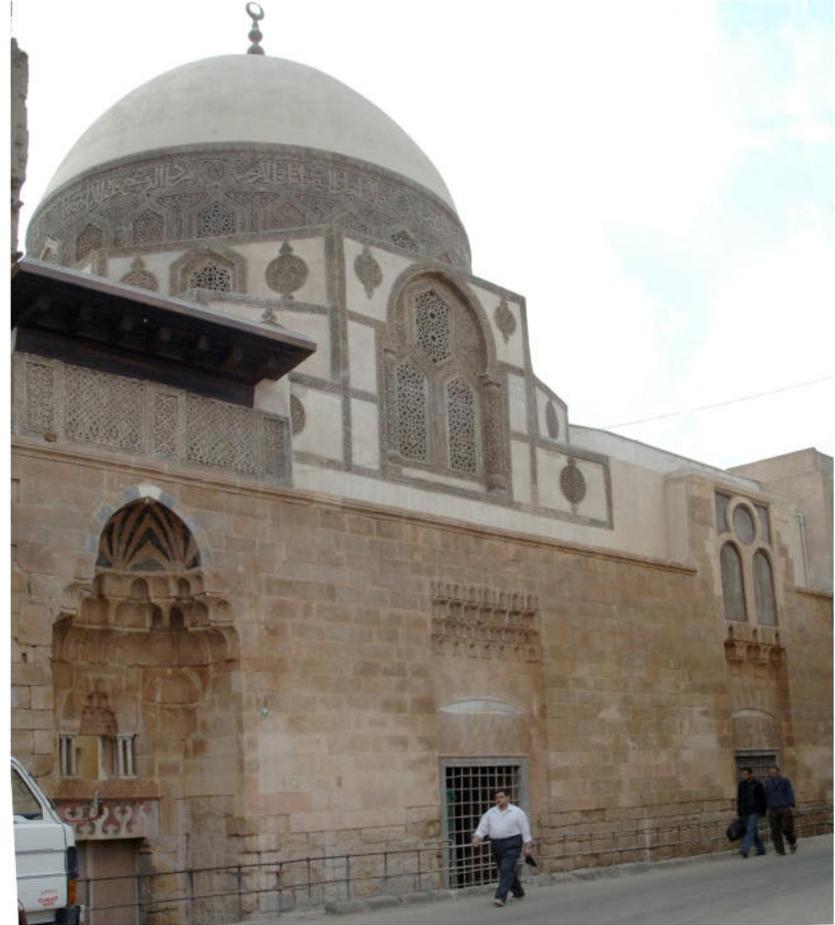
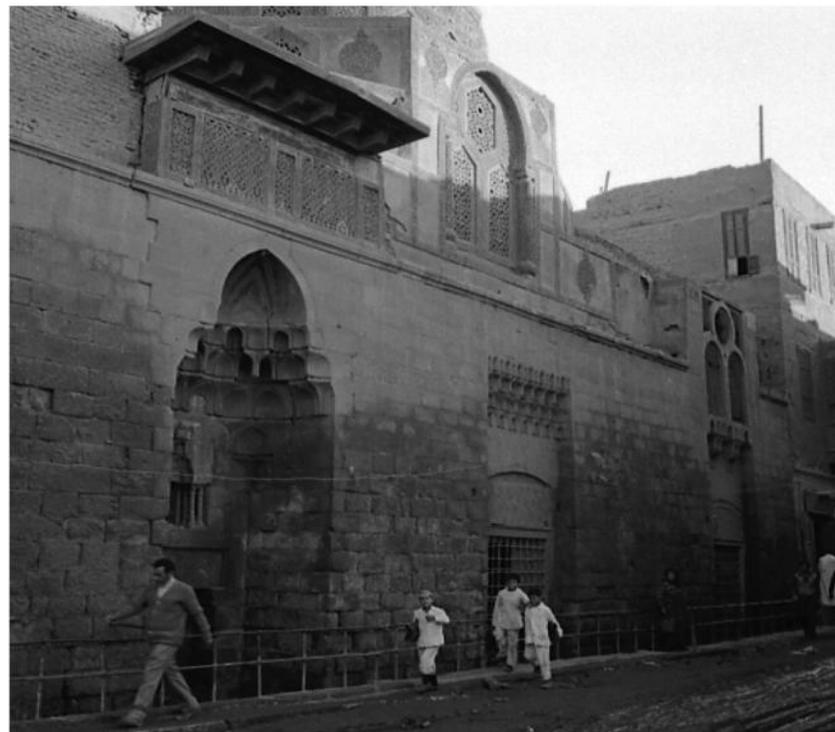
Fig. 21. EXTERIOR OF THE MAUSOLEUM BEFORE AND AFTER RESTORATION

After completing the sandblasting, we reintegrated the stone ashlar corroded by the action of salts. We preferred an action of integrative restoration instead of a replacement of the ashlar (fig. 21). We kept the original material and avoided the shock that would be caused by the replacement of ashlar and the consequent settling of the wall structures.

But, even more important, we gave the students the opportunity to practice in proportioning the components of mortars, colouring earths, and to have training for the stone conservation (fig. 21). Finally, all the external surfaces of the mausoleum, decorations, stuccoes and stone facings were protected with ethyl silicate (Rhodorsil RC90) by Rhone Poulenc and then with water-repellent Rhodorsil H224.
