**Art and Archaeology Research Papers**

## NOTES ON THE RESTORATION OF 'THE SMALL THEATRE OF THE DANCING DERVISHES' AT SHARE HELMEIA IN CAIRO

Carla Maria Burri and Giuseppe Fanfoni

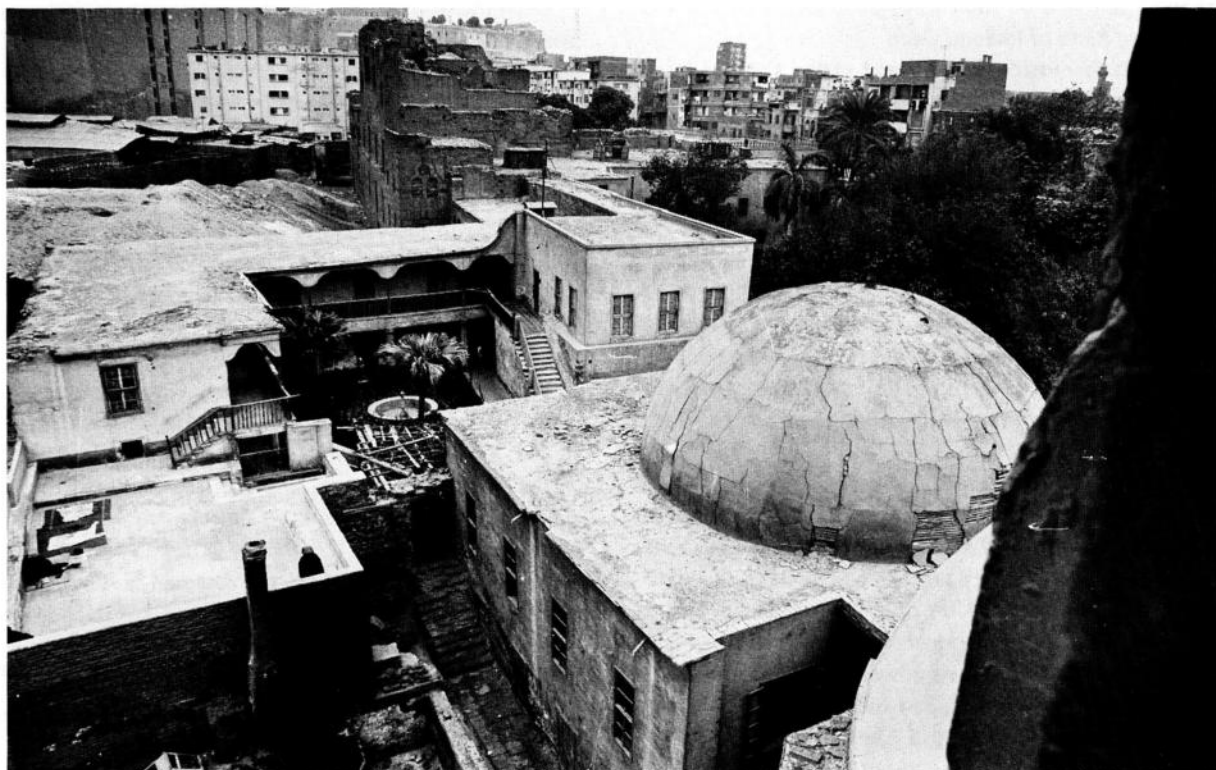
View of the theatre and convent.
